A Case Study – Blast Damaged Industrial Building – Insurance claim settlement

By - Er. Ravi Ranade

Blast Damage Assessment Audit :-

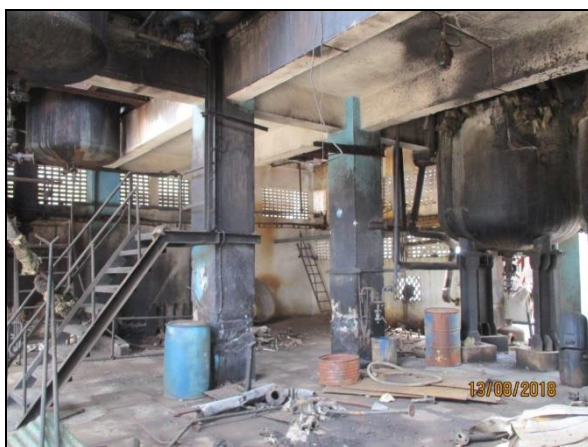
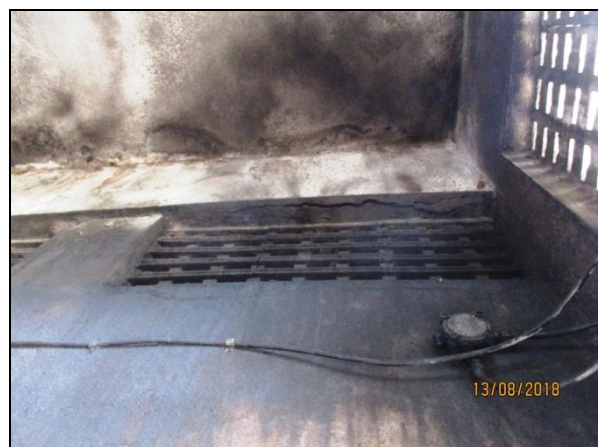
RCC members around blasted area – Ground floor

Apparently no structural cracks in any of members due to blast, but only corrosion cracks

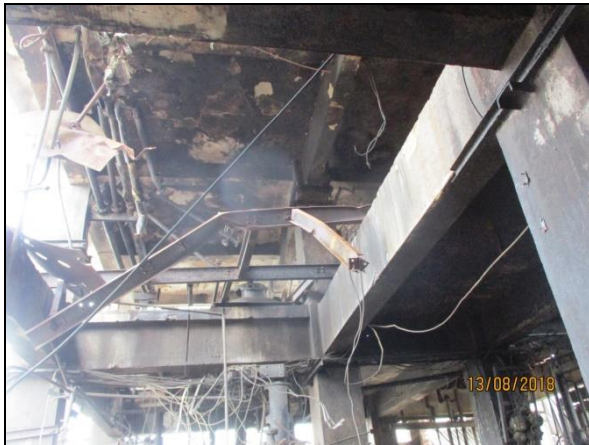
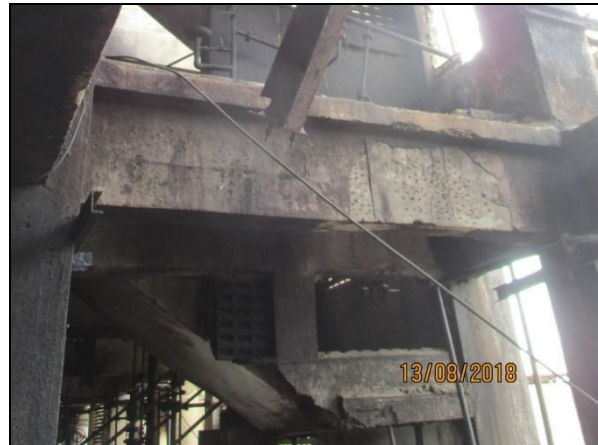
RCC / Steel members around blasted area – First floor

Apparently no structural cracks in any of members due to blast, but only corrosion cracks

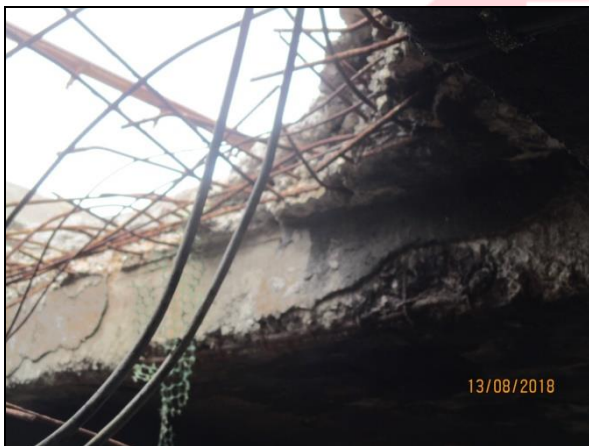
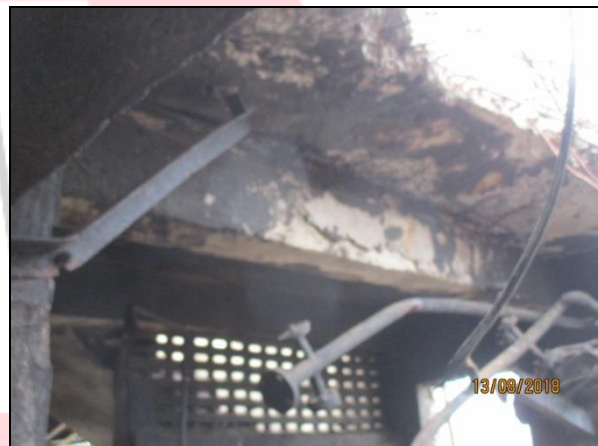
Totally damaged roof slab due to Blast (Two slab panels)

- 6) Thus, we concluded that, the blast damage was limited only to the two roof slab panels (as against the claim of, total damage of the building, made by the owner). Along with slab damages some other associated partial damages in walls, RCC grills, waterproofing and plaster can be certified for claim settlement -

Description	Damage – Extent – Full / Partial / Nil	Requires – Reconstruction / Repair
Roof RCC slab panels (2 Nos) along with ceiling plaster & waterproofing	Full	Reconstruction
RCC Grill along with plaster touch-ups and painting, as marked in the sketch	Partial	Replacement of all fully damaged grills
Brick parapet walls along with plaster and painting, as marked in the sketch	Partial	Replacement of all fully damaged walls
Fallen plaster over ceiling of slabs, and RCC members	Partial	Replacement of all fully damaged plaster over RCC members

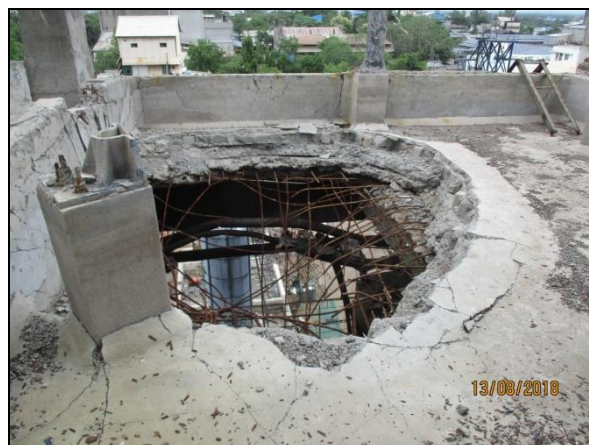
Totally damaged roof slab due to Blast

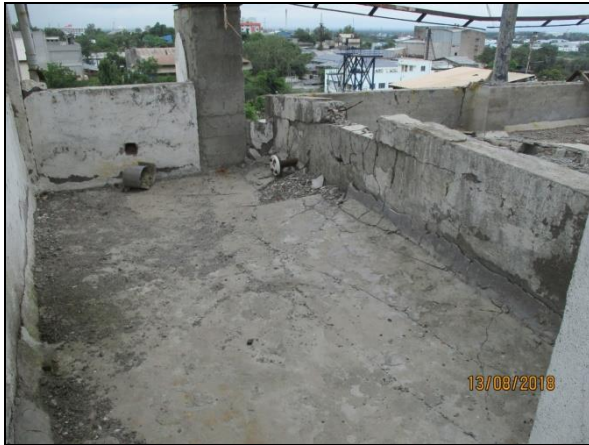
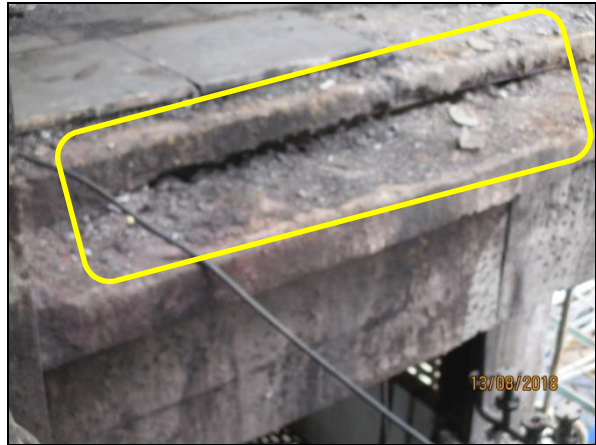
Roof slab adjacent to staircase – crackd and lifted up

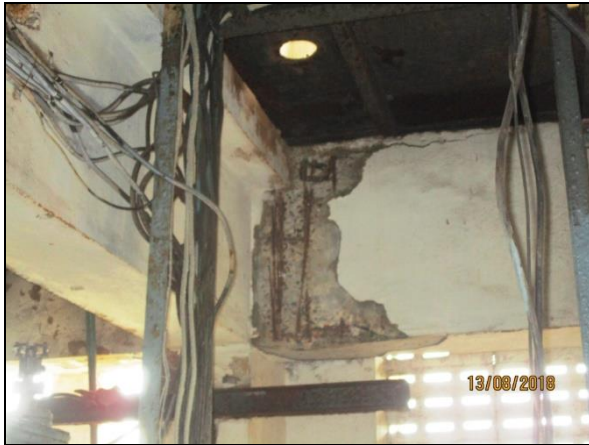
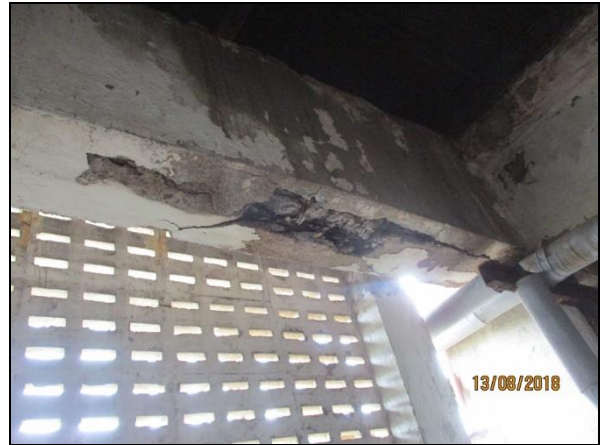
Moderate to Severe corrosion of reinforcement along with spalling of cover concrete

- 4) It is observed that, both the buildings had a very serious issue of corrosion of reinforcement. All visible cracks in RCC members were mainly due to corrosion of the reinforcement steel. The crack widths indicated that, the corrosion of reinforcement is probably of moderate to severe level.

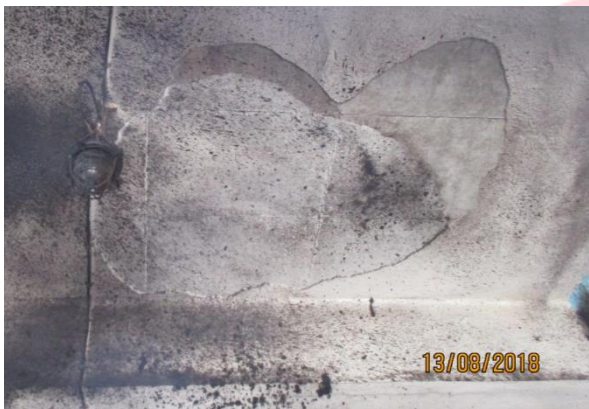
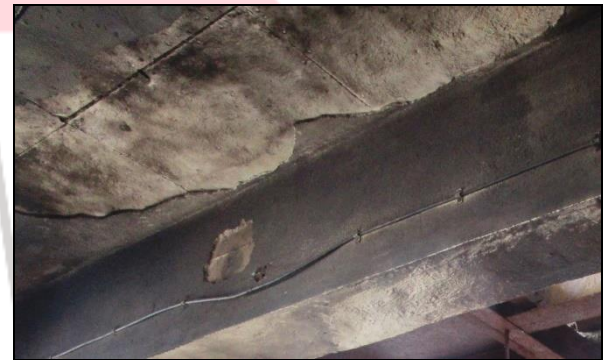
Ceiling plaster fallen due to blast

- 2) At some locations the plaster over slab ceiling & other RCC members had fallen due to impact of the blast.
- 3) At some locations the parapet walls and RCC grill had collapsed due to blast impact.

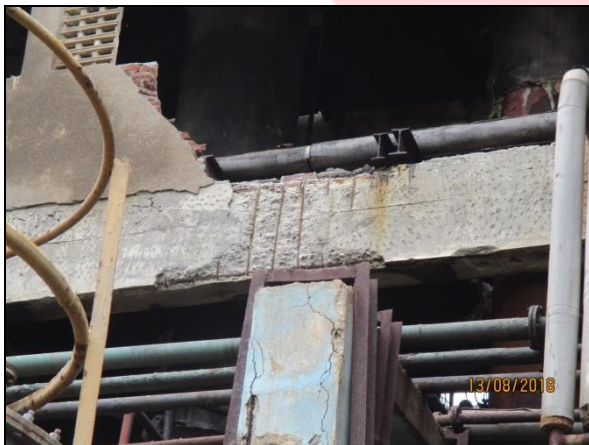
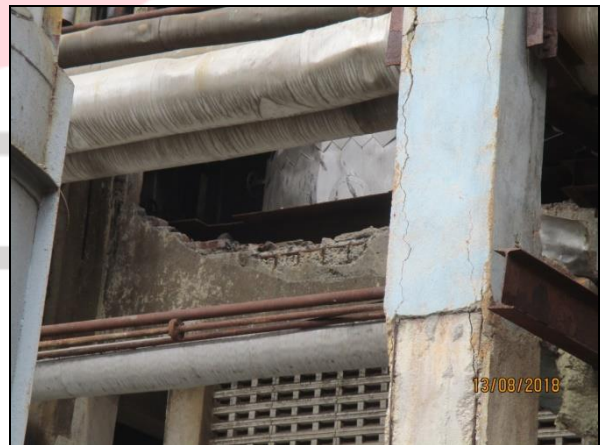
Plaster over RCC member fallen and parapet wall & RCC Grill collapsed due to blast

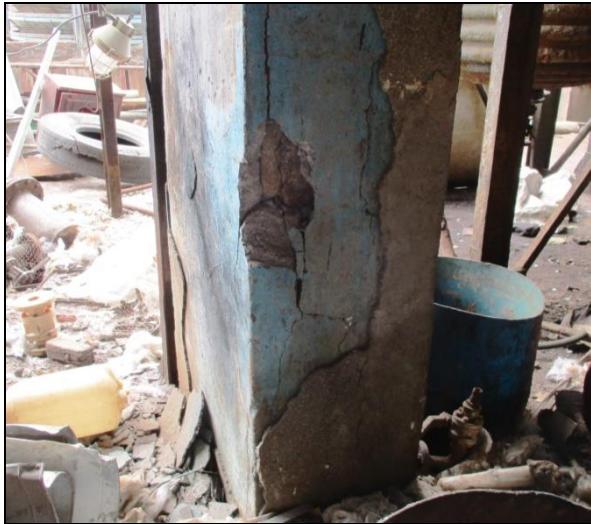
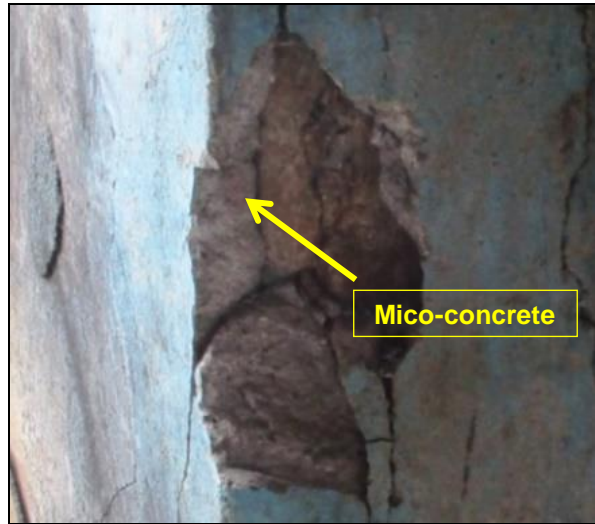
All columns of old building were jacketed with Micro-Concrete 25 to 75 mm thick

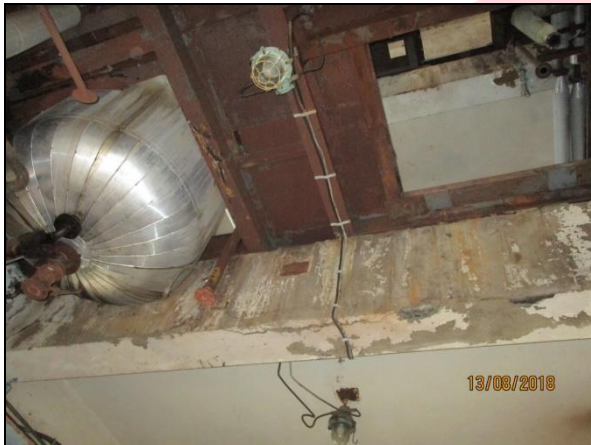
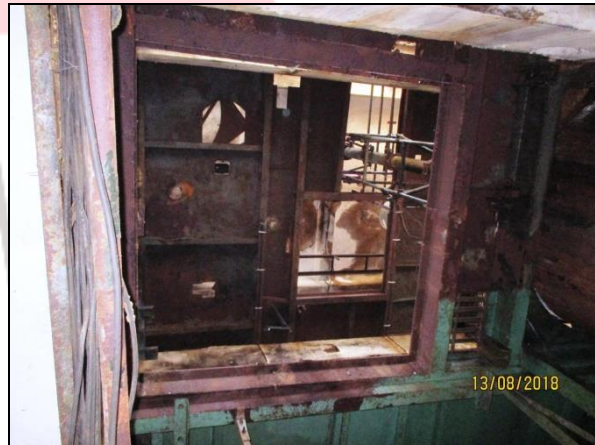
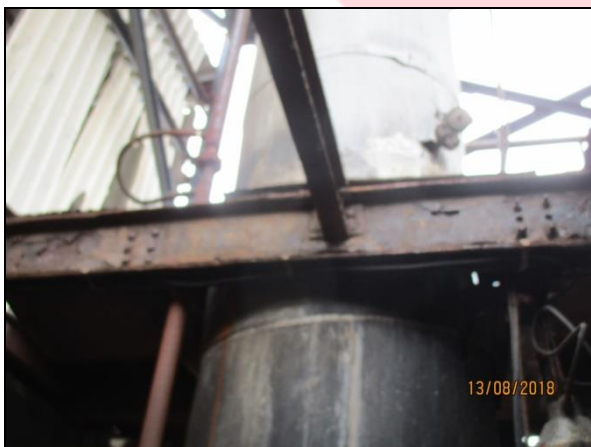
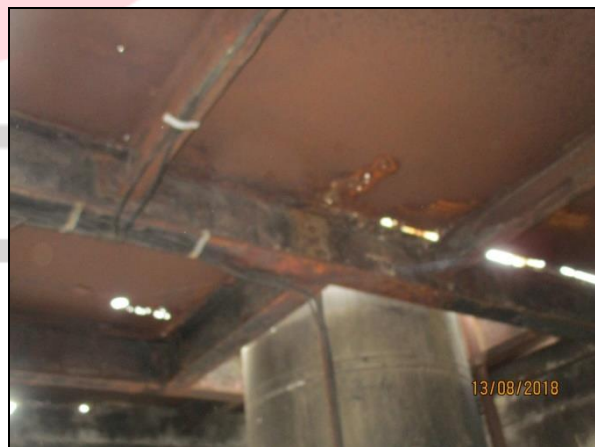
Structural steel members with minor to moderate corrosion

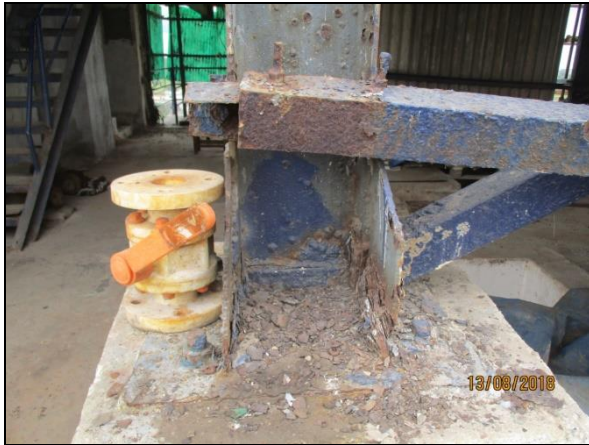
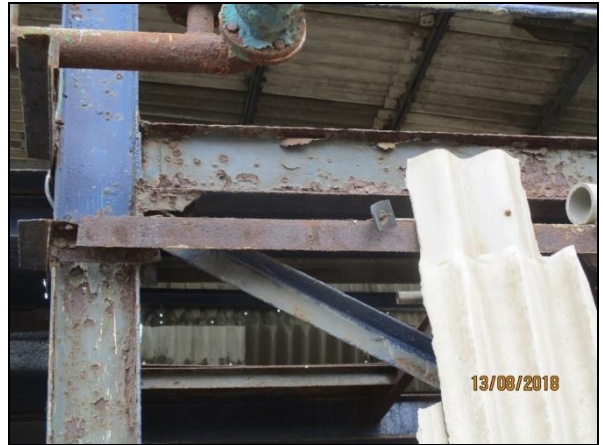
Structural steel members with Severe corrosion

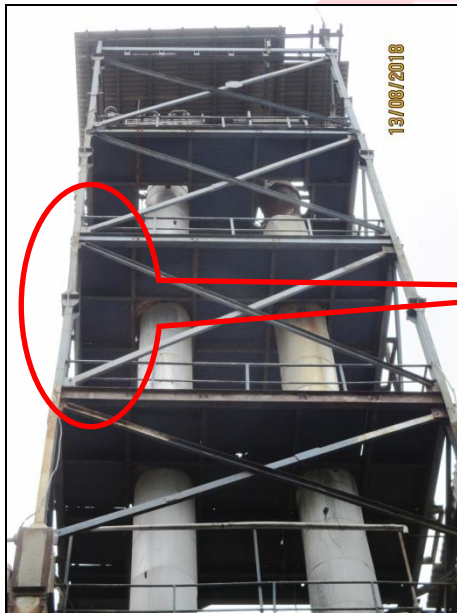
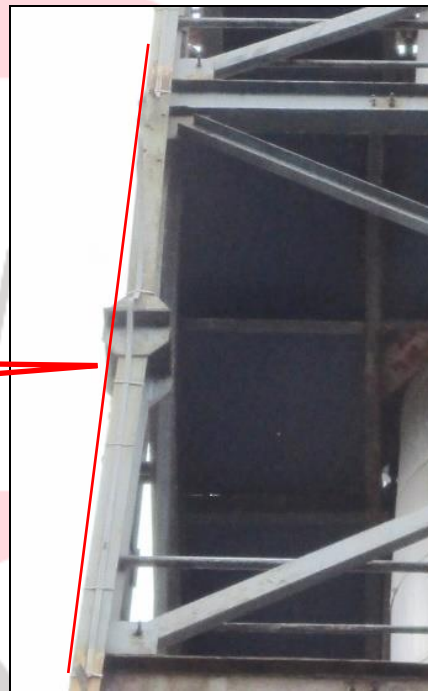
Bend at column joint

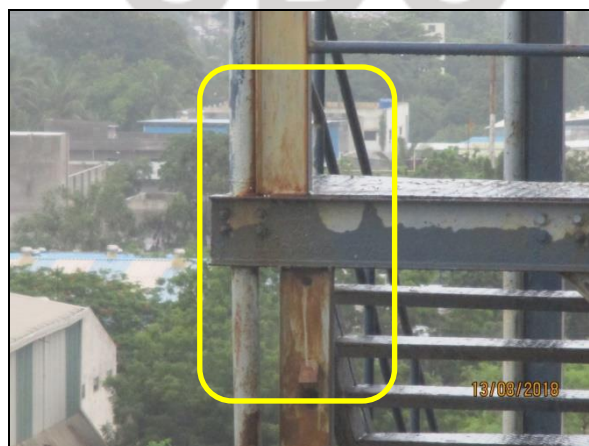
Misaligned Structural Column of staircase of east side Steel tower
