Blending Silo Failure Investigation for A Kenyan Cement Factory

Case Study

Blending Silo Failure Investigation For A Kenyan Cement Factory

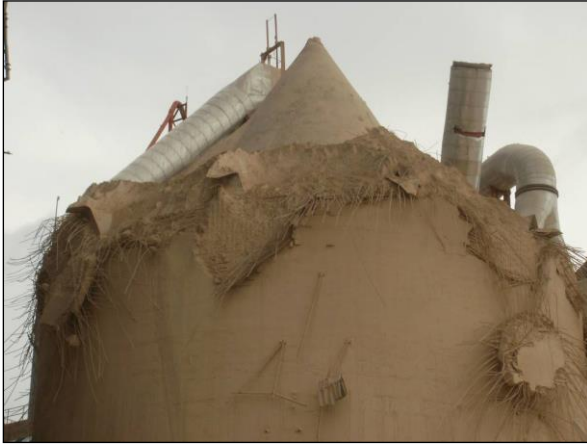
- Complete collapse of the blending silo above the junction of wall and bottom conical slab at 19.5 – 20.0m level.
- Major portion of the Silo observed collapsed on the North and rest of the concrete wall including the stored material collapsed on other side.
- No visible cracks noticed on the remaining RCC wall.
- Clear cover to the wall reinforcement was observed to be about 75 to 100 mm.
- Yielding of the reinforcing bars not observed. Majority of the bars were either noticed to be cut like a shear failure or opened out at splice locations.
- None of the reinforcing bars were noticed to have any sort of corrosion.

Wall Collapse at about 19.5 to 20.0 m level

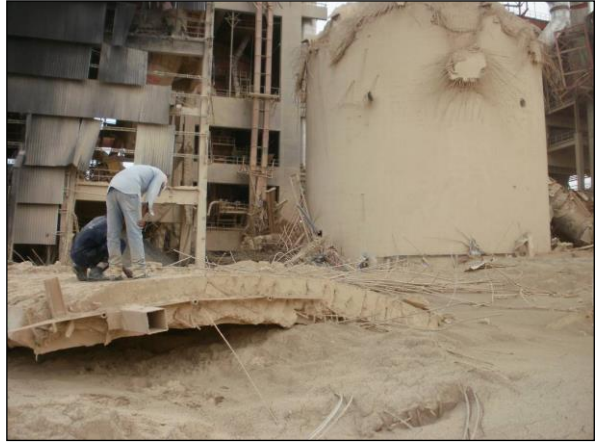
Major Wall portion Collapsed on North side

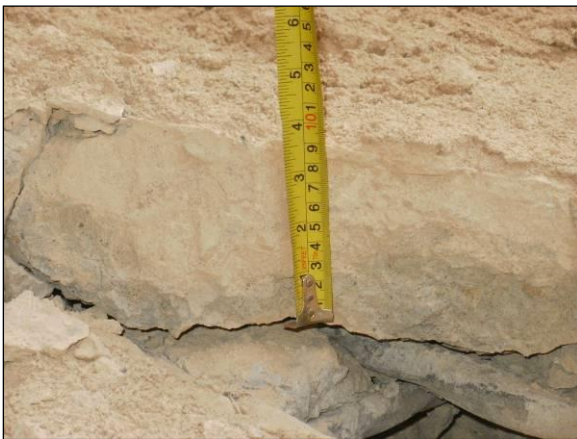
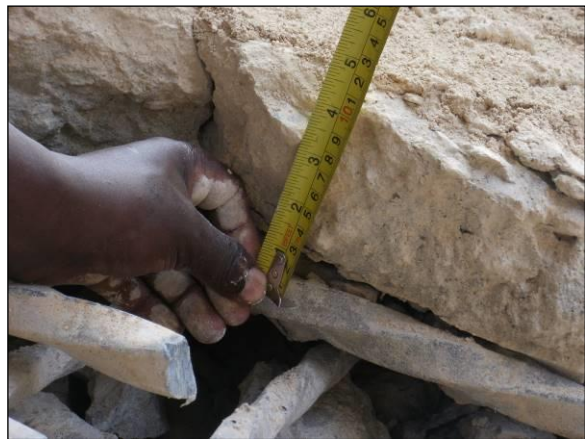
- v. Due to reduction in lever arm i.e. higher cover value of @ 100 mm, the required steel in wall above 17.5 m level was more than what was provided.

8. The vertical steel on inner face for the silo wall above 17.56 m level was insufficient for both M-30 and M-20 grade of concrete. The extra cover provided at site (100 mm) was also demanding additional vertical steel on inner face.

Excessive Cover to the reinforcement at 75 to 100 mm

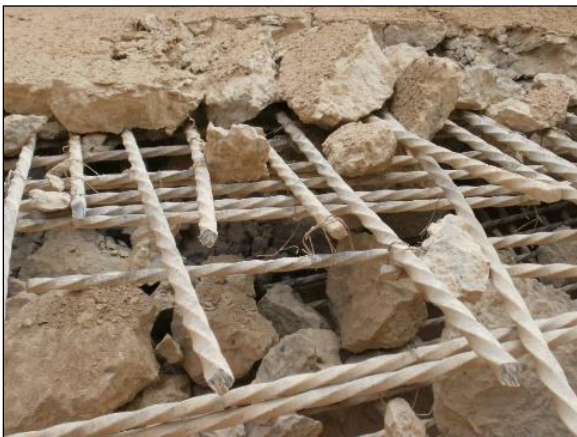
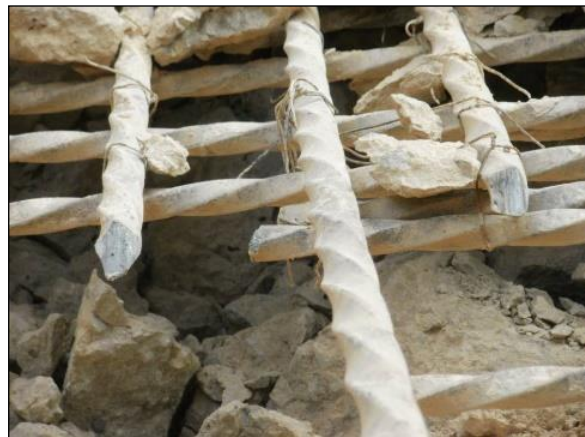
Bars not yielded

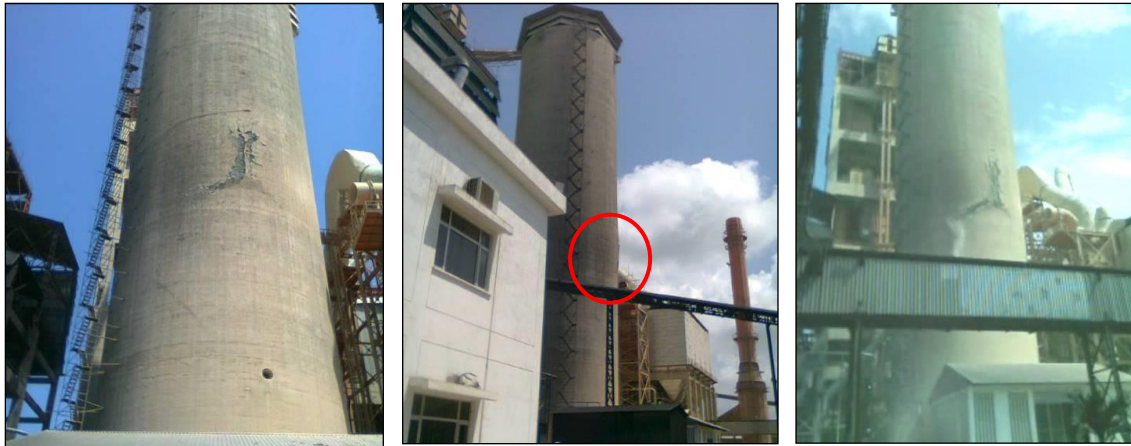
- Crack was first noticed at 0700 hrs.
- It took 7 hours for the silo to collapse after the crack was noticed
- The crack was associated with spalling of cover concrete and the reinforcement was exposed
- A bulge was observed at 20 to 30 m height
- Just before failure, concrete began to peel
- The stored material oozed out from the horizontal crack for few seconds just before collapse.
- Wall bulged more
- A wide and long horizontal circumferential crack developed within a fraction of seconds and the entire silo above 20 m level collapsed.
- No vibrations noticed in the Silo or the pipes / Ducts / adjoining Structures connected to the Silo before the collapse

11. One of the cold joints caused by interruptions in concreting was at 27 m level, close to the location of the horizontal crack which was developed on the day of collapse and which got expanded at the time of failure.

***Vertical & Horizontal Crack / split at 30 m to 38 m Level. with a Bulge.
Oozing of material Spalling of cover concrete was also observed.***

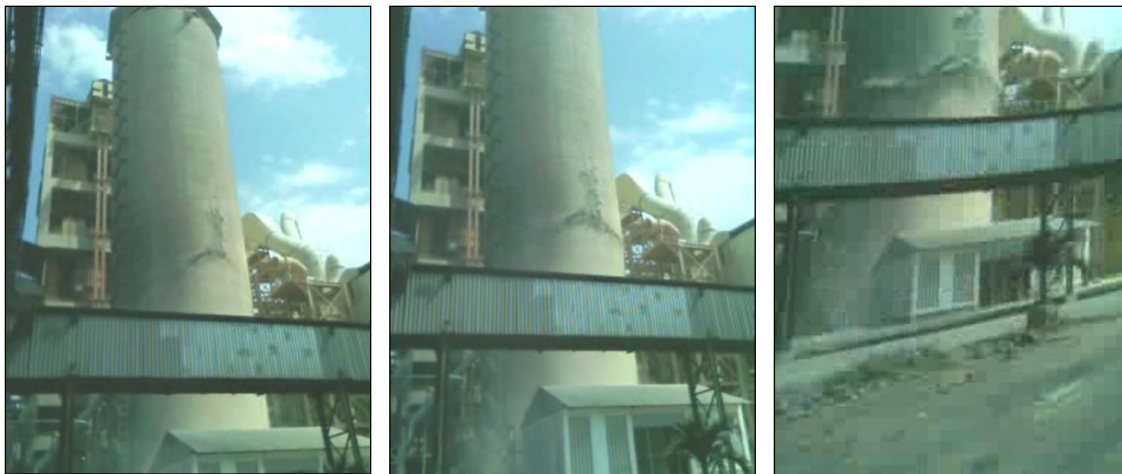
05 Sec before collapse Oozing stopped - 1.00 Sec before collapse Crack widened- 0.25 Sec. On the verge to Collapse
